AEFA PROJECT NO. 84-23

# ARTIFICIAL AND NATURAL ICING TESTS OF AH-64 (PHASE II)

MARCH 1987

FINAL REPORT

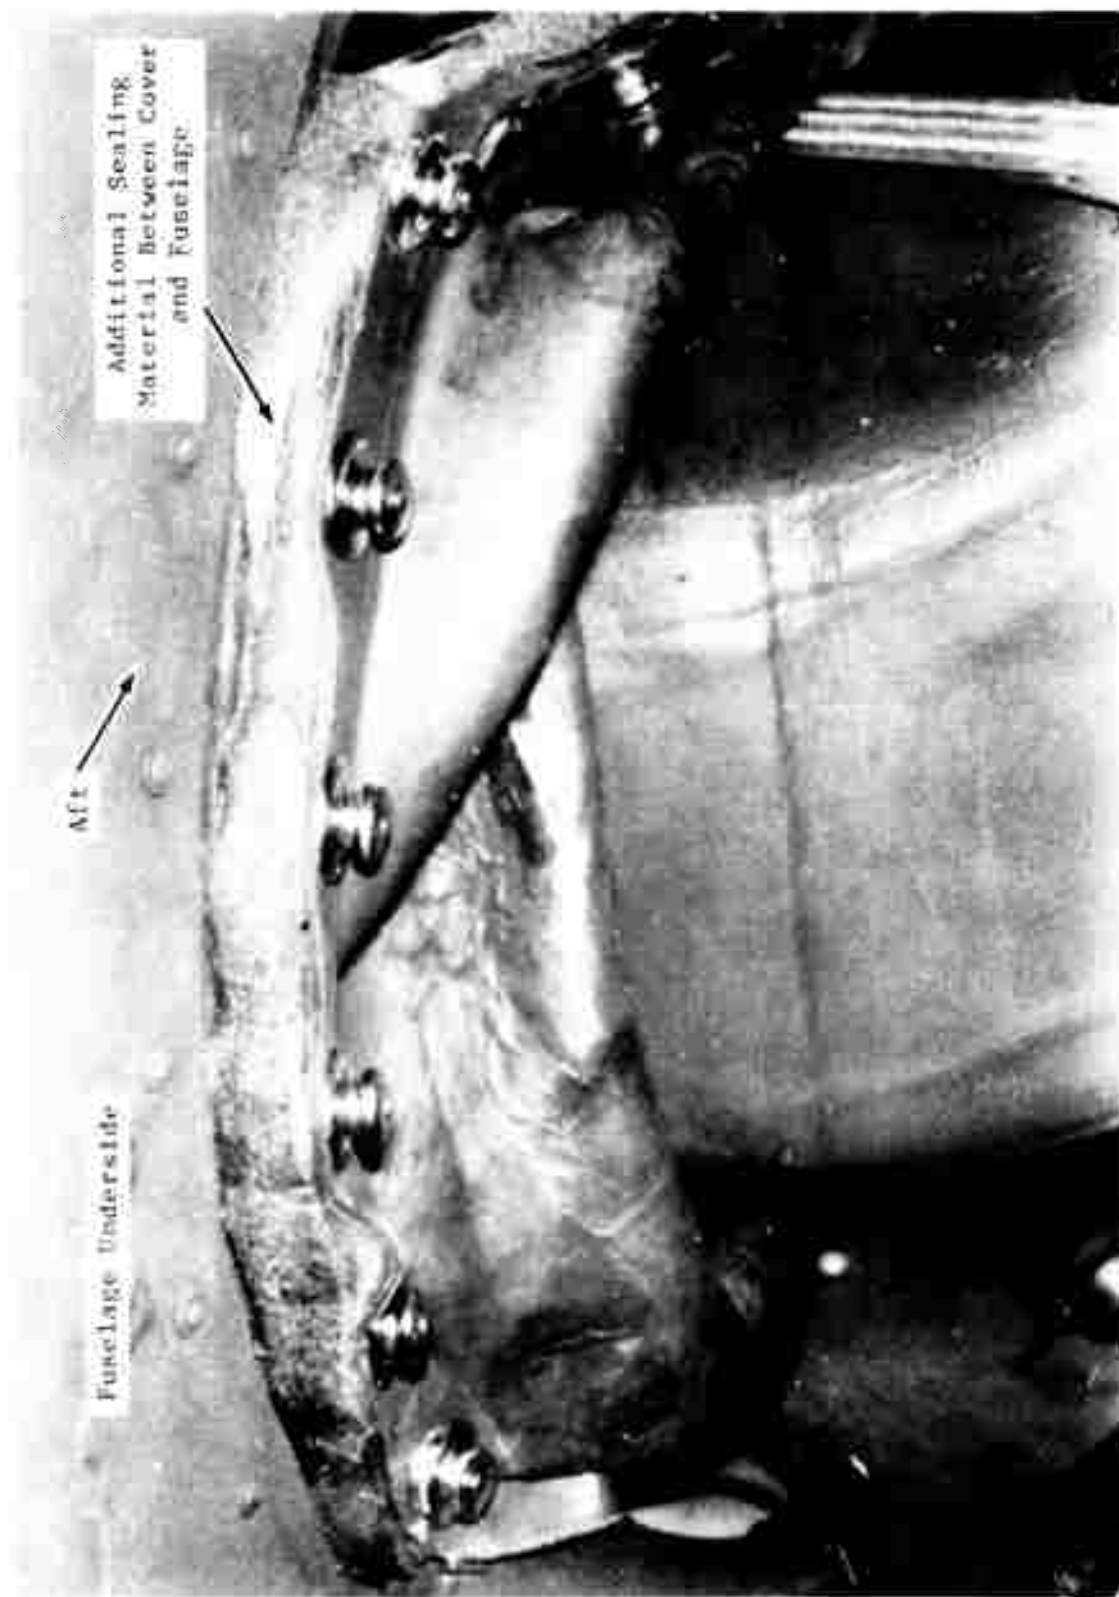
Photo 8. 30mm Ammunition Chute Cover - Upper Portion

38. The ice accretion and shedding characteristics of the 30mm chain gun area weapon system were evaluated in natural icing conditions. Weapons firing was not attempted following flight in icing conditions. Although live fire operations were not performed, the accreted ice did not hamper the traversing operation of the weapon. The gun was traversed in-flight through its full range in azimuth and elevation to verify unrestricted motion. A muzzle protector made of cloth prevented ice build-ups inside the barrel. An environmental cover (photo 7) was installed on the ammunition chute and turret assembly. This dual purpose cover prevented both ice accumulation inside the chute which would jam ammunition feed and cold air from entering the aft cockpit through the turret assembly. An additional seal was installed to improve the seal between the cover and the lower fuselage (photo 8). The ice accretion and shedding characteristics of the area weapon system are satisfactory. The production configuration of the area weapon environmental cover should incorporate a seal between the cover and fuselage similar to the one used on the test aircraft.

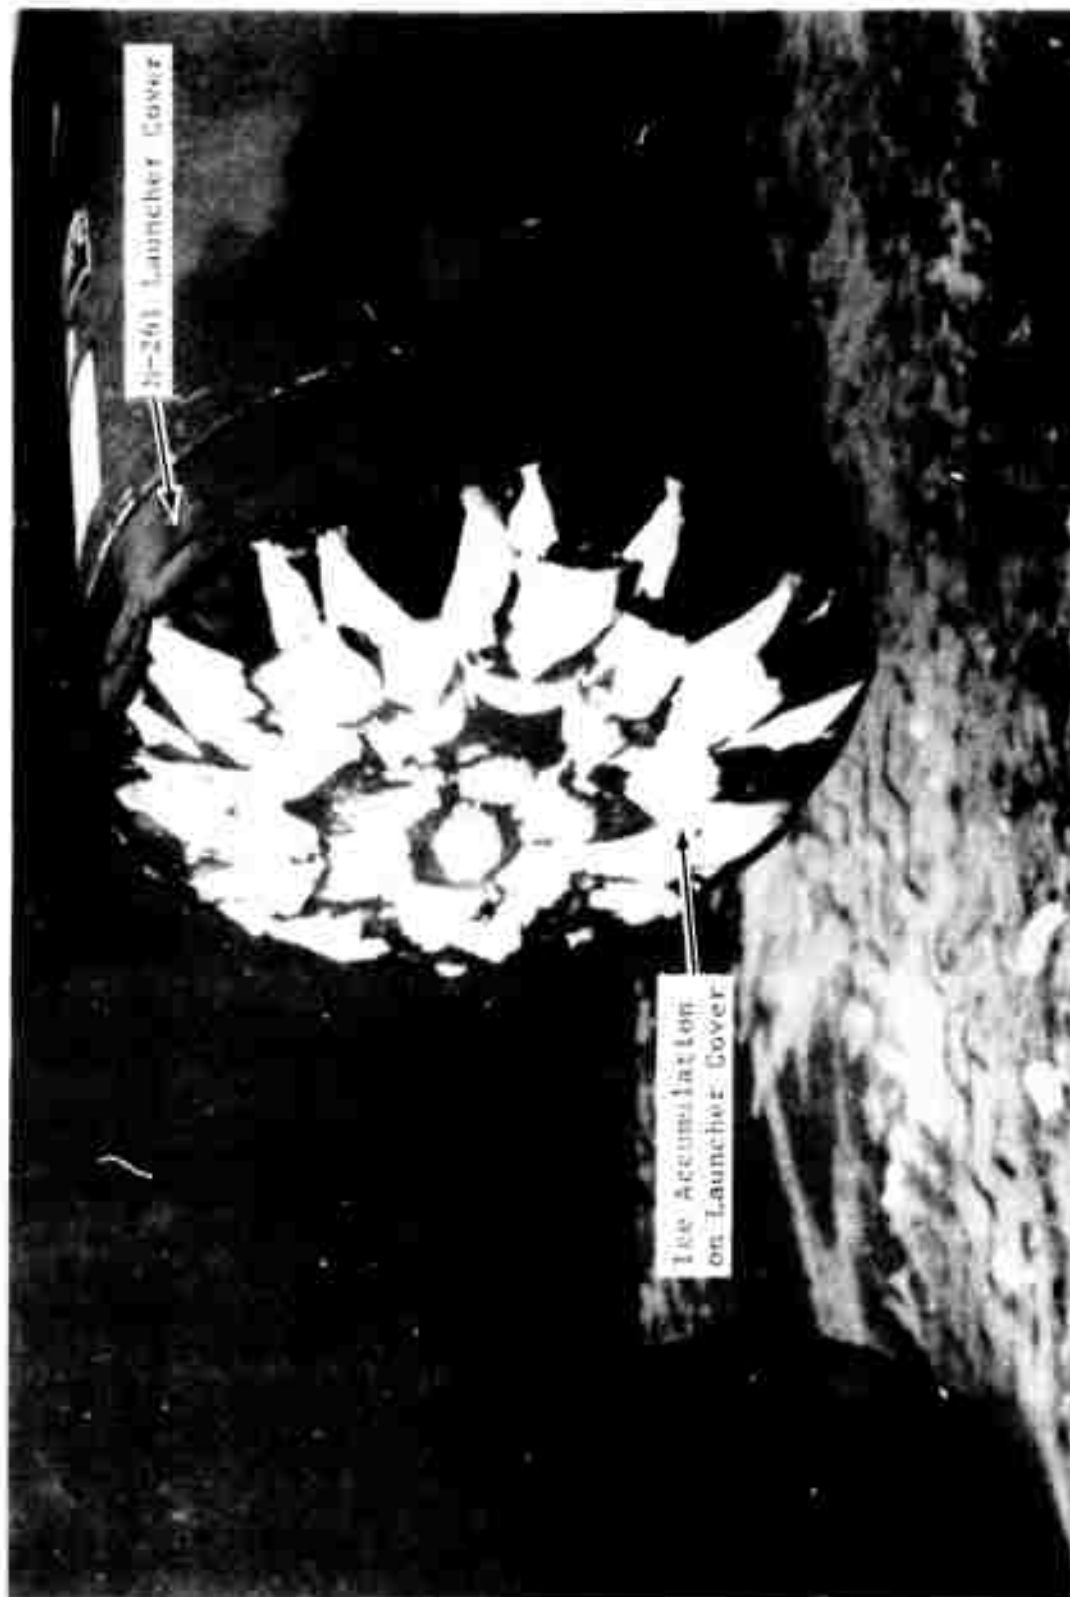
Photo 9. Left Wing Store - N-261 Lightweight Rocket Launcher

39. The ice accretion and shedding characteristics of the M-261 lightweight rocket launchers were evaluated during this test. Protection covers identical to those previously described and tested (app F) were installed on the launchers. Ice accreted on the protective covers as shown in photo 9. Rocket firing was not attempted following an icing encounter. The ice accretion and shedding characteristics of the M-261 lightweight rocket launcher are satisfactory. A test should be conducted to determine the consequences of the M-261 protective covers departing the launcher, with and without accumulated ice.

Conditions: Avg LWC =  $0.33 \text{ gm/m}^3$

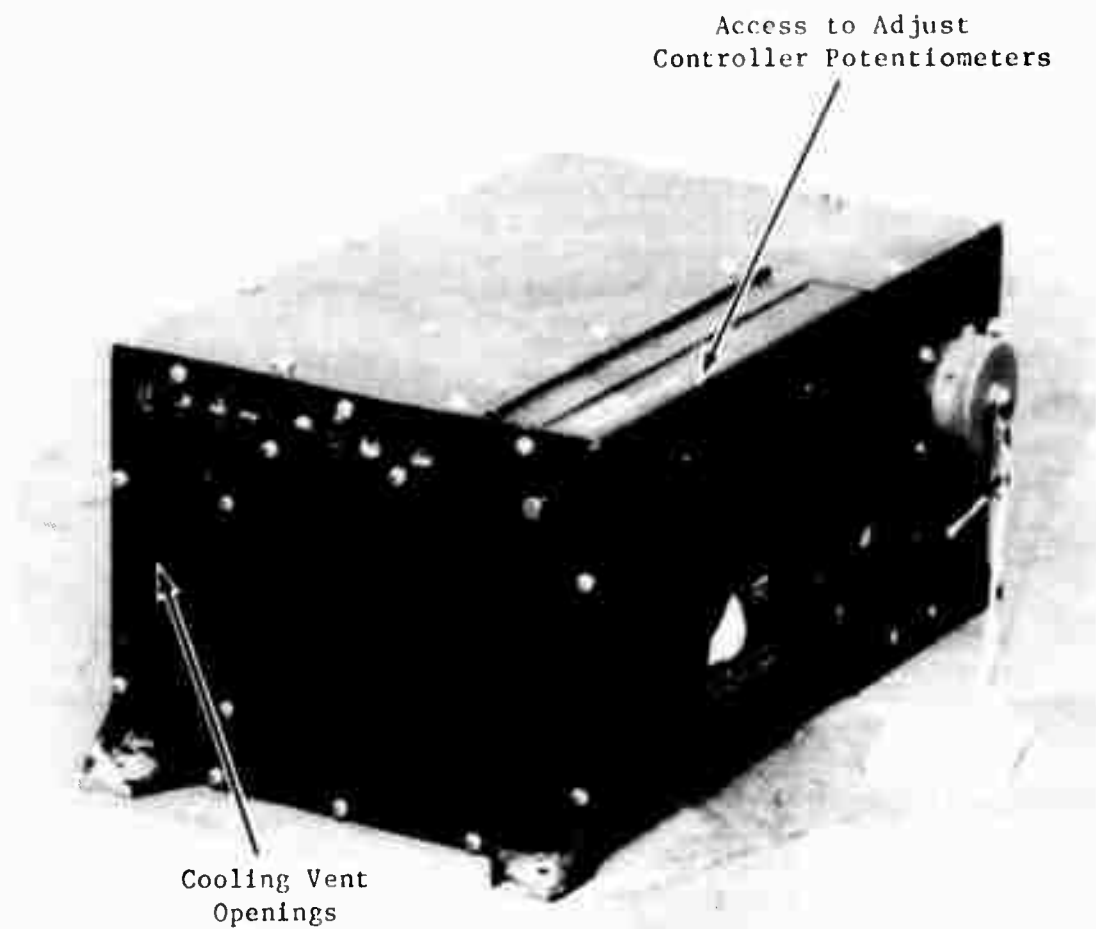
Photo 11. AH-64A Deice Controller

48. The main and tail rotor deice controller is mounted on the forward transmission deck (photo 10). Cooling vents and a fan

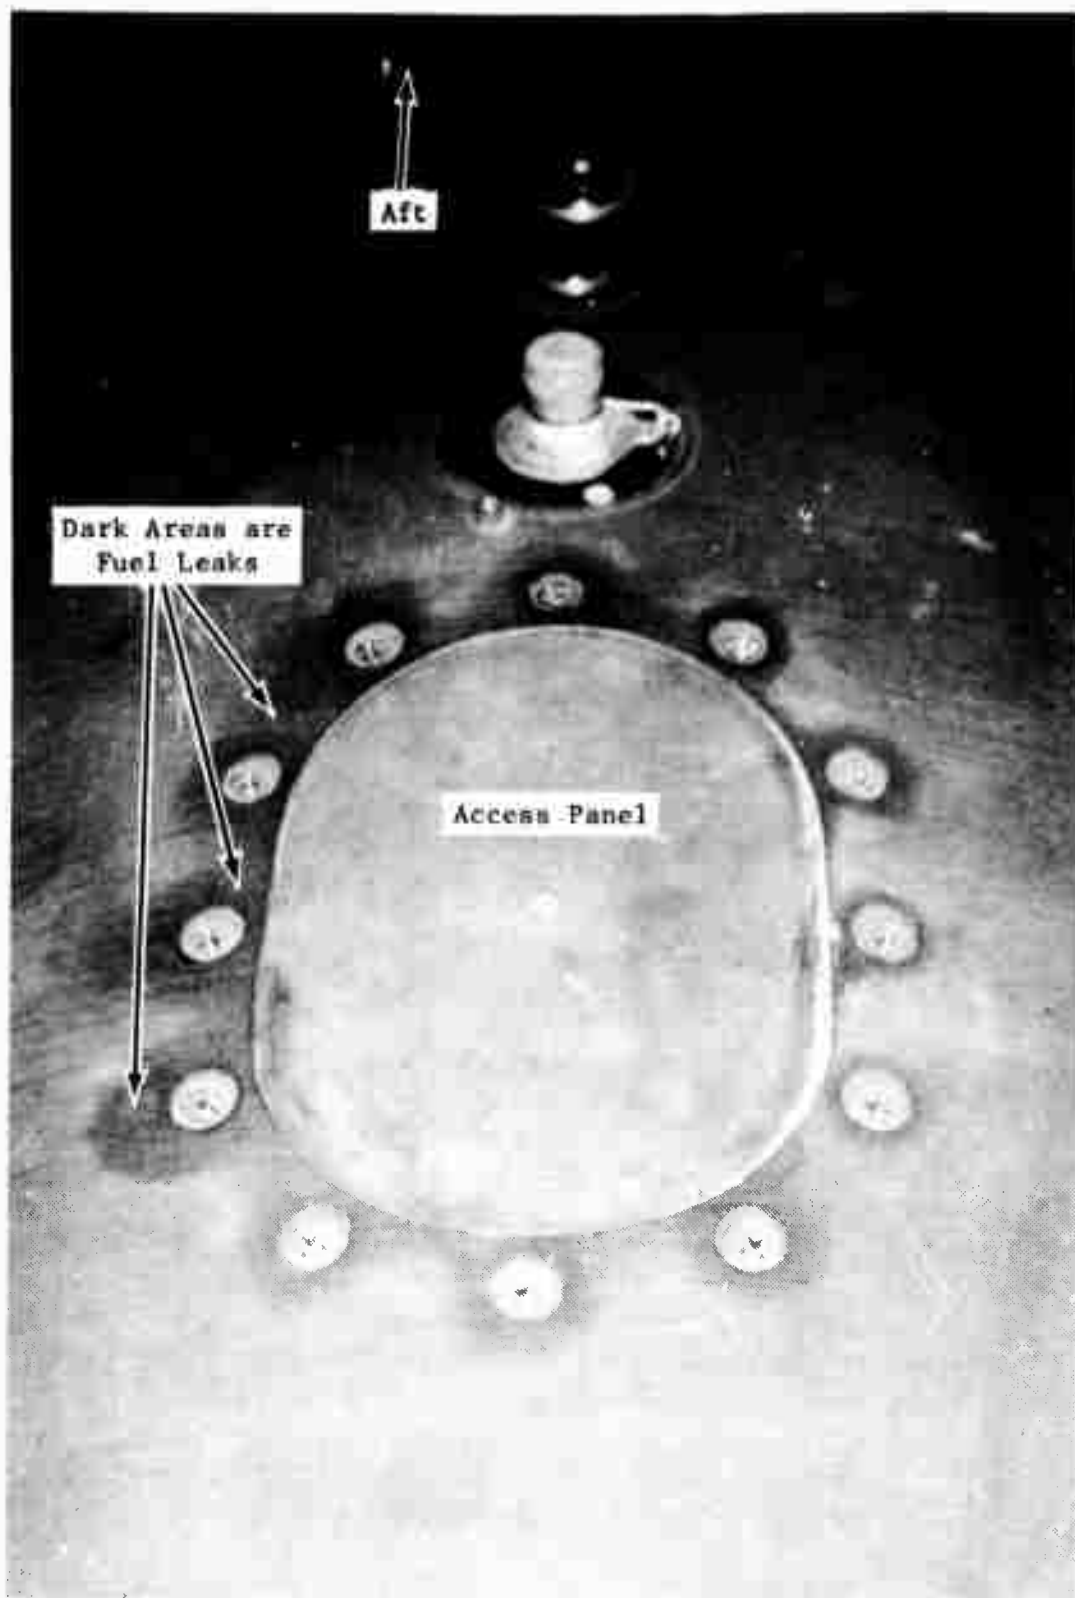
Photo 13. Auxiliary Fuel Tank - Top View

51. External auxiliary fuel tanks were installed on the test aircraft (photo 12). Fuel was transferred from the external tanks by means of the pressurized air system. When the aircraft is shutdown, the external tanks remain pressurized. When the aircraft was hangared for several days with the tanks pressurized, fuel began leaking from the tank access panels (photo 13) and fuel line fittings. The only way to vent pressure from the external tanks was to open the fuel filler caps following each flight. The tendency of the external auxiliary fuel tanks to

leak when the aircraft is stored after normal shutdown is a shortcoming.

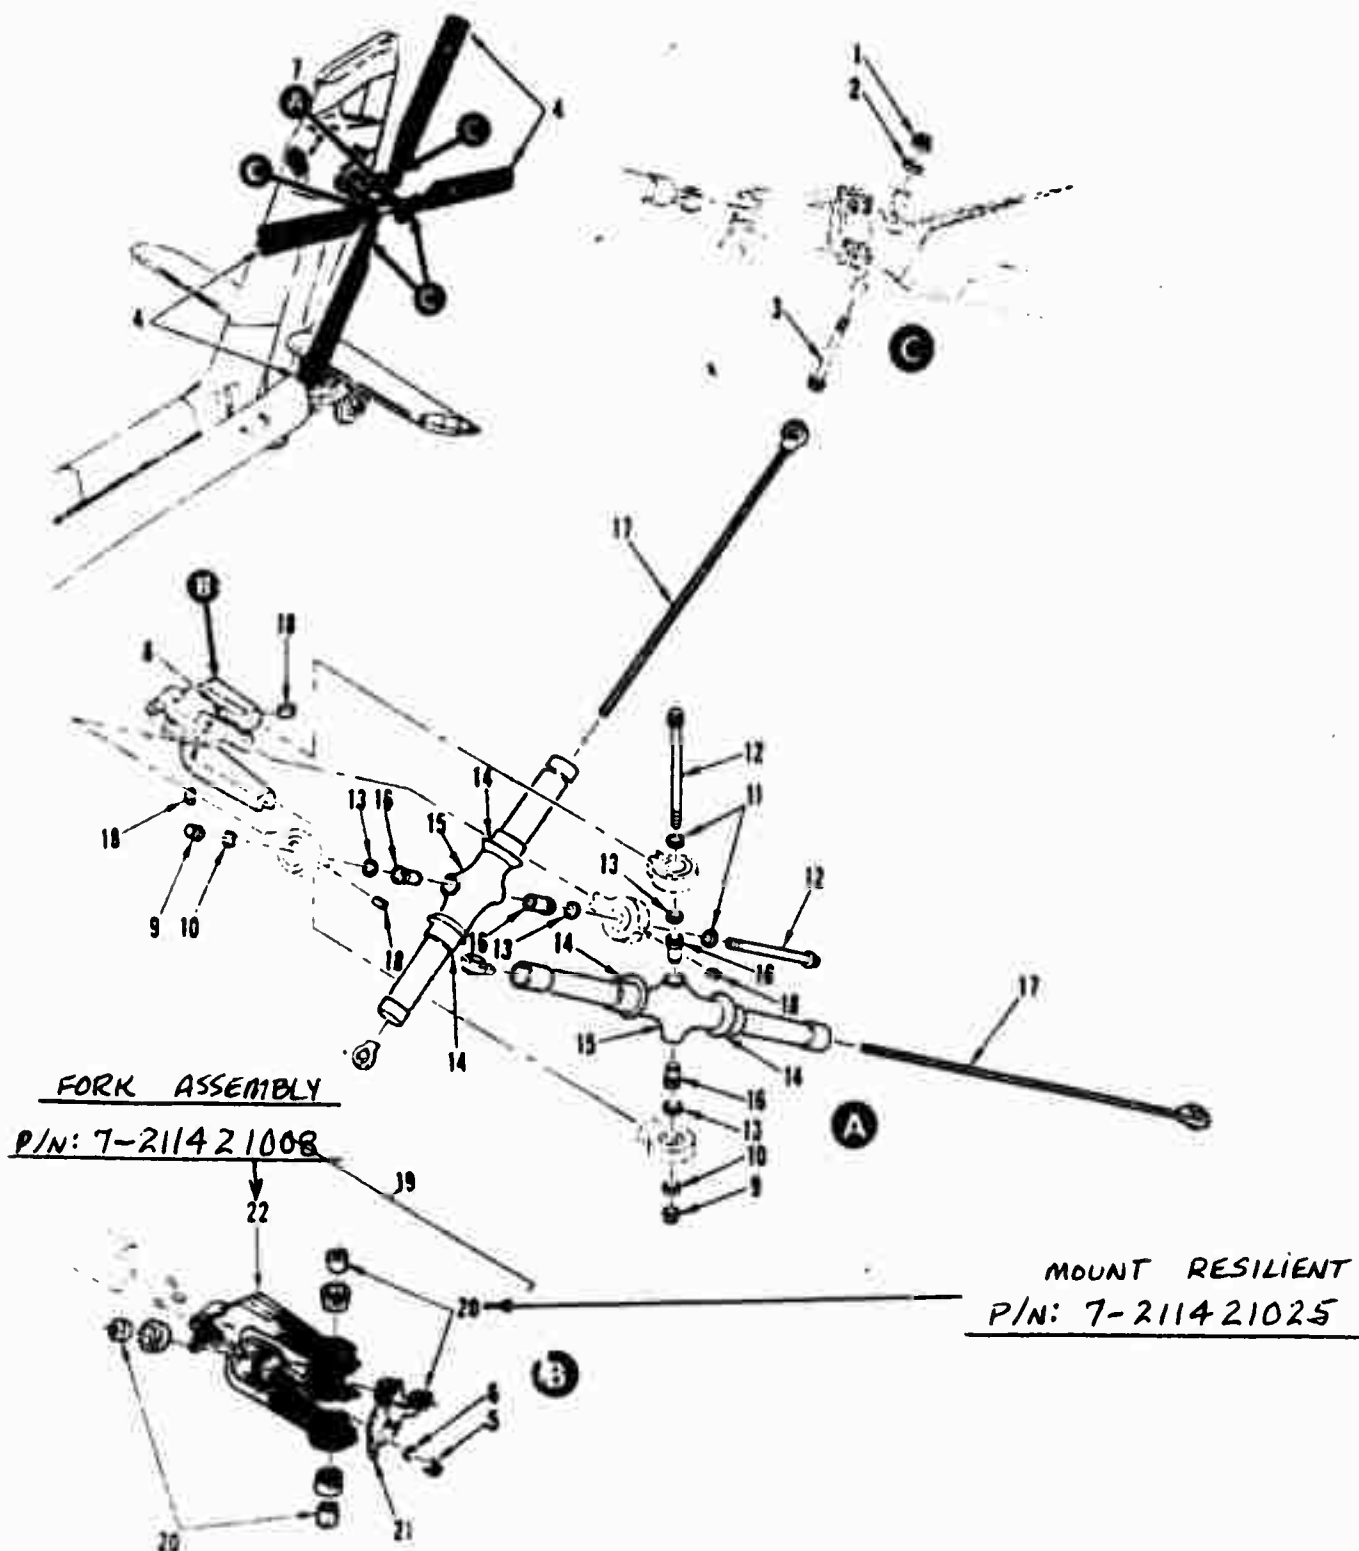
**FIGURE 127. GROUP 05 TAIL ROTOR INSTALLATION  
(HEAD BLADES) 7-311420002**

d. OTHER		c. MINOR		f. NONE	
<b>IV INCIDENT DESCRIPTION</b>					
26. DESCRIBE INCIDENT FULLY (INCLUDE IMPACT OF INCIDENT ON MAC CODE IDENTIFIED IN BLOCK 22): <p>During ground inspection, after No. 2 flight, resilient mount was found to have debonded from forked housing on tail rotor yoke housing. Further inspection revealed only one of the four mounts had debonded. Maintenance crews removed the outboard T/R to remove debonded mount. Clean up on fork assembly and old mount was required before rebonding and cure time. Proceeded through bonding procedures titled: Bonding Procedures for the 7-211421008 Tail Rotor Fork Assembly. Time cured before testing bond on ground was approximately 20 hours. Ground run was accomplished approximately 22 hours after bonding. Ground inspection after run revealed no debonding. Balancing of T/R was required after rebonding of mount.</p> <p>Reference: TM 55-1520-238-23 and 23P; Fig. 127, Item 20</p>

26. DESCRIBE INCIDENT FULLY (INCLUDE IMPACT OF INCIDENT ON MAC CODE IDENTIFIED IN BLOCK 22): During ground inspection following a ground run for tail rotor change due to T/R damage on FLT 15, resilient mount was found to have debonded from forked housing on tail rotor yoke hosuing. Further inspection revealed only one of the four mounts had debonded. Maintenance crews removed the outboard T/R to remove debonded mount. Clean up on fork assembly and old mount was required before rebonding and cure time. Proceeded through bonding procedures titled: Bonding Procedures for the 7-211421008 Tail Rotor Fork Assembly. Time cured before testing bond on ground was approximately 20 hours. Ground inspection after run revealed no debonding. Balancing of T/R was required after rebonding of mount. This was not the same elastometric bearing that was debonded on FLT #2 (see EPR #004).  REFERENCE: TM 55-1520-238-23 and 23P; FIG. 127 ITEM 20.

26. DESCRIBE INCIDENT FULLY (INCLUDE IMPACT OF INCIDENT ON MAC CODE IDENTIFIED IN BLOCK 22):					
<p>During ground inspection following Flight #17 the resilient mount was found to have debonded from forked housing on tailrotor yoke housing. Maintenance crew removed the outboard T/R to remove debonded mount. Repair was made as before on mount I.A.W. rebonding procedures (See EPR #004). Mount cured for the 24 hours and then was run-up for T/R balancing. This was the same mount that debonded after Flight #15 (See EPR #010). Tailrotor balancing was good and ground inspection after run found no discrepancies with bonding of mount.</p>					
REFERENCE: TM55-1520-238-23 AND 23P; FIG.127, ITEM 20.					
INCIDENT CLASSIFICATION IS SUBJECT TO RECLASSIFICATION

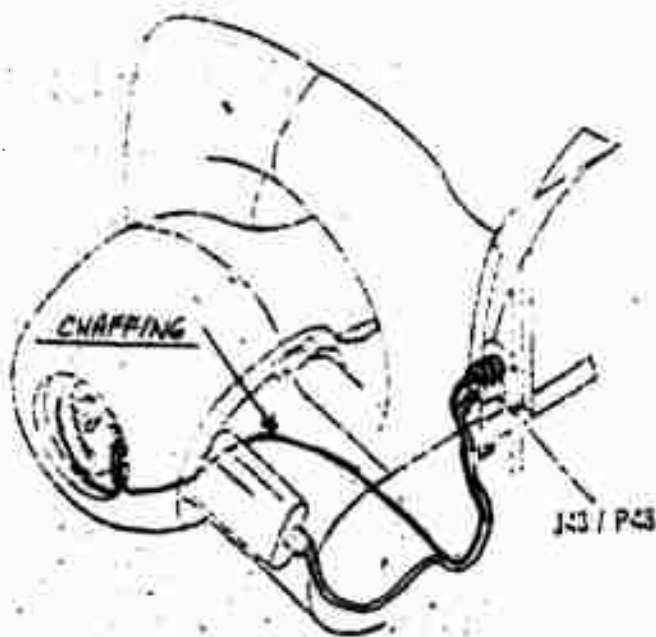
ENGINE 2 NOSE GEARBOX FAIRING

26. DESCRIBE INCIDENT FULLY (INCLUDE IMPACT OF INCIDENT ON MAC CODE IDENTIFIED IN BLOCK 22):					
<p>When installing nose gearbox fairing, lower half, P/N: 7-311140174-2, the wire bundle to the nose gearbox was found to be pinched between the fairing and fan (D/S Covering) P/N: 7-31132001. There was no definite indication to the desired routing or anywhere to secure the wires from being left to dangle. Further inspection revealed the wires had been chaffing in that area due to no way to secure them to fairing. Velcro had been tried but it appeared that it doesn't hold. An alternate routing was tried behind a fairing support (see * on drawing), but connector at J48/P48 location was short from routing and won't connect.</p> <p>See Attached Drawings.</p>					
INCIDENT CLASSIFICATION IS SUBJECT TO RECLASSIFICATION

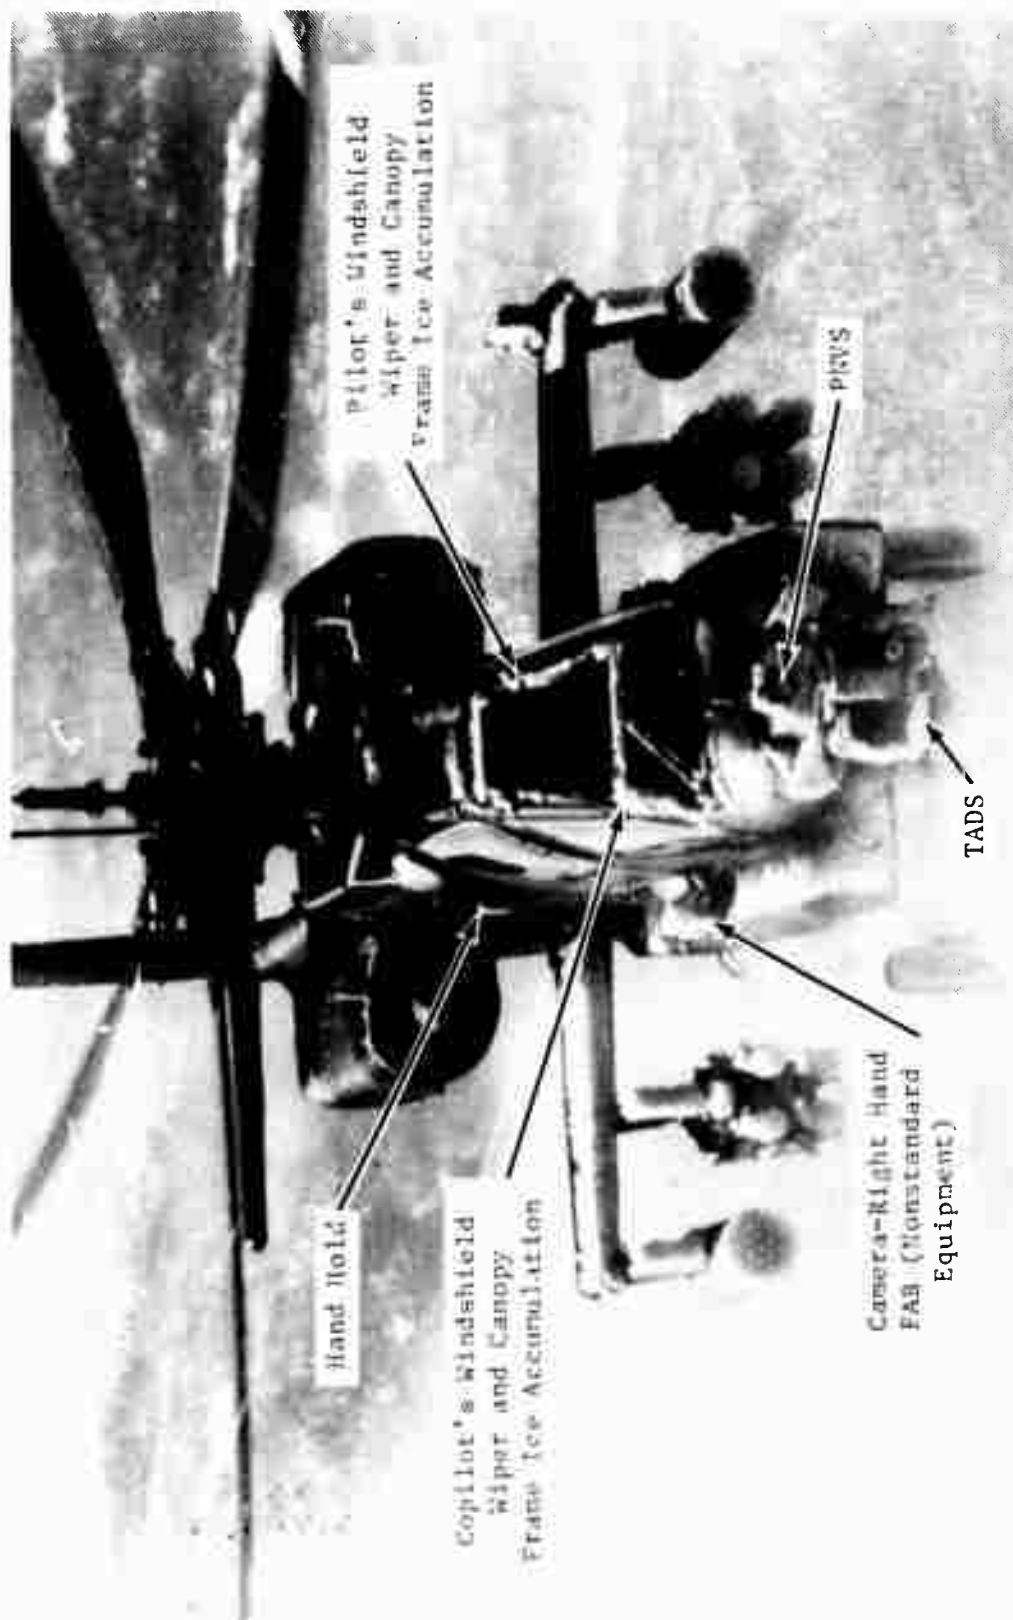
Photo 4. Typical Fuselage Ice Accretions

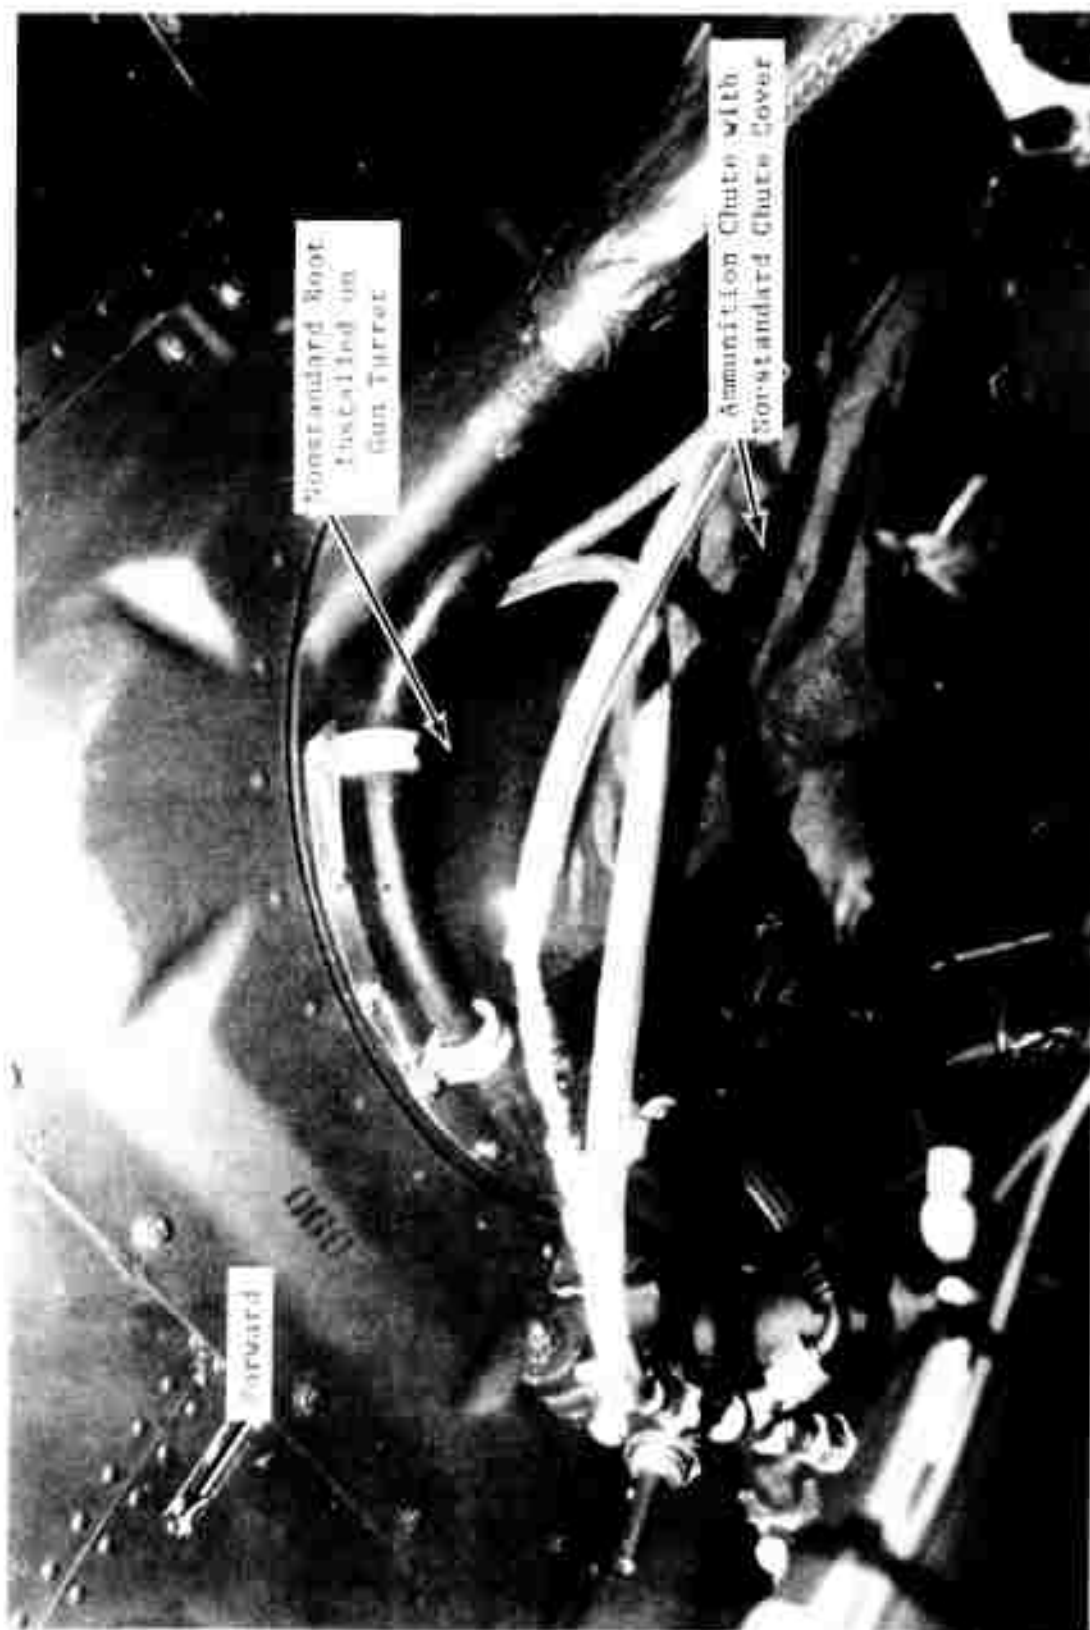
Photo 10. Aircraft Underside View - 30mm Chain Gun Turret

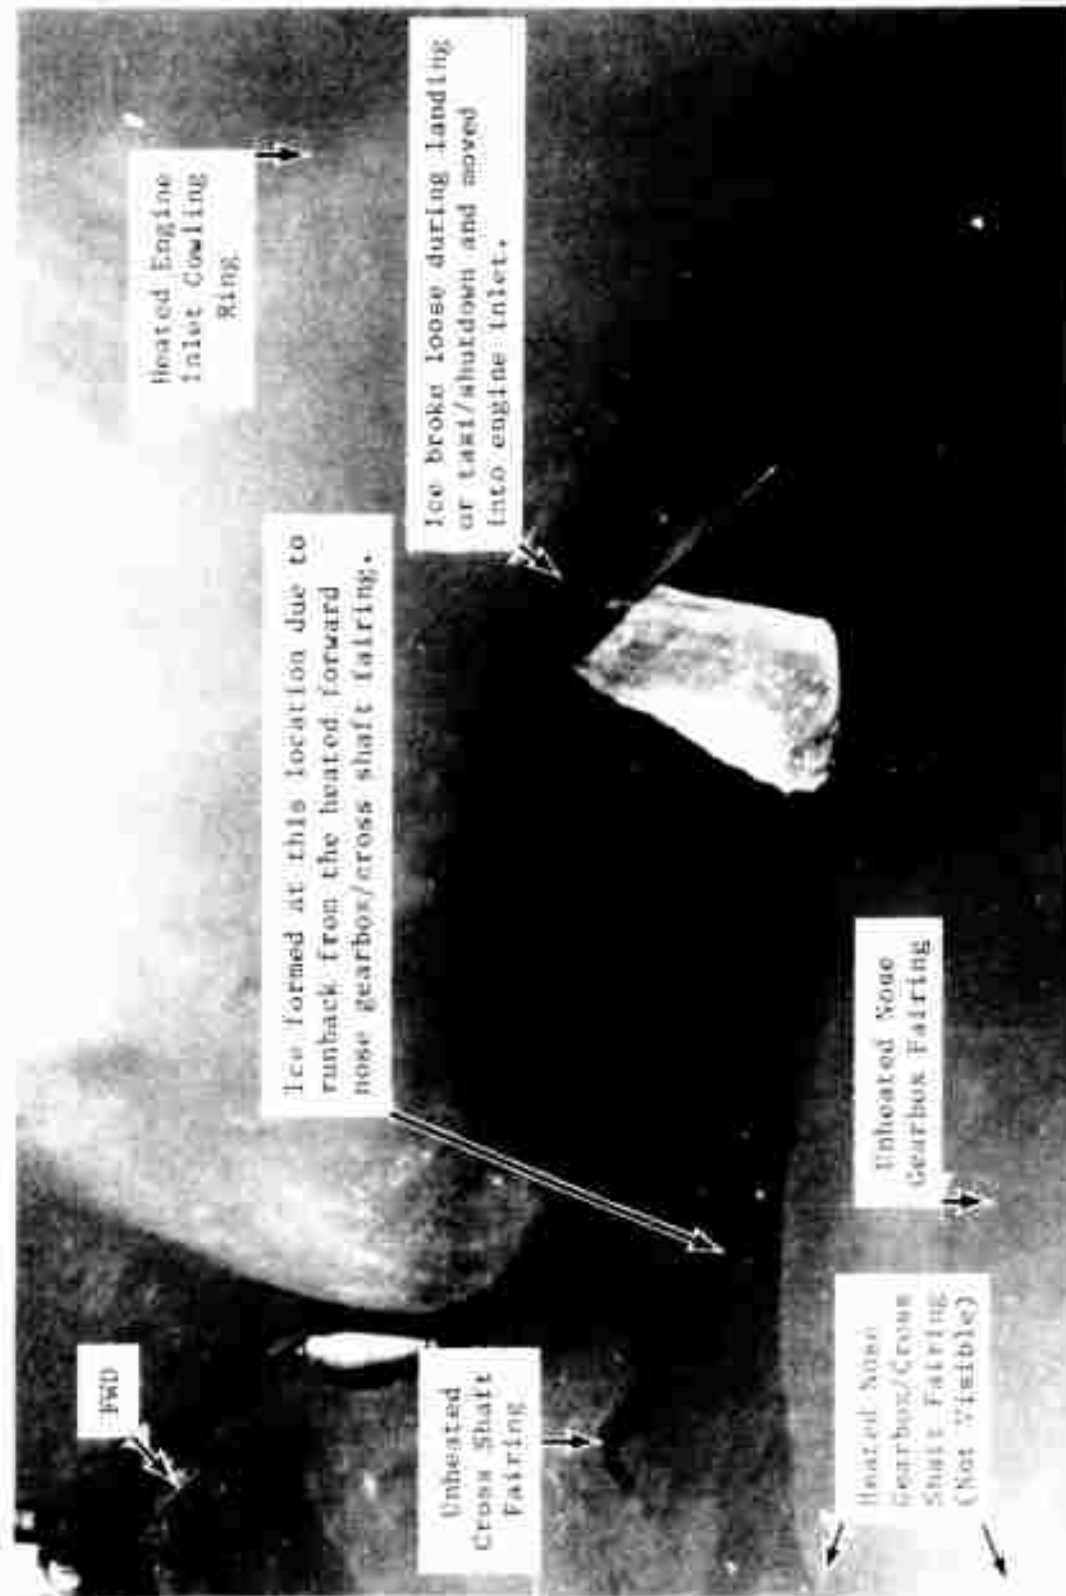
Photo 4. AH-64 No. 1 Engine Inlet

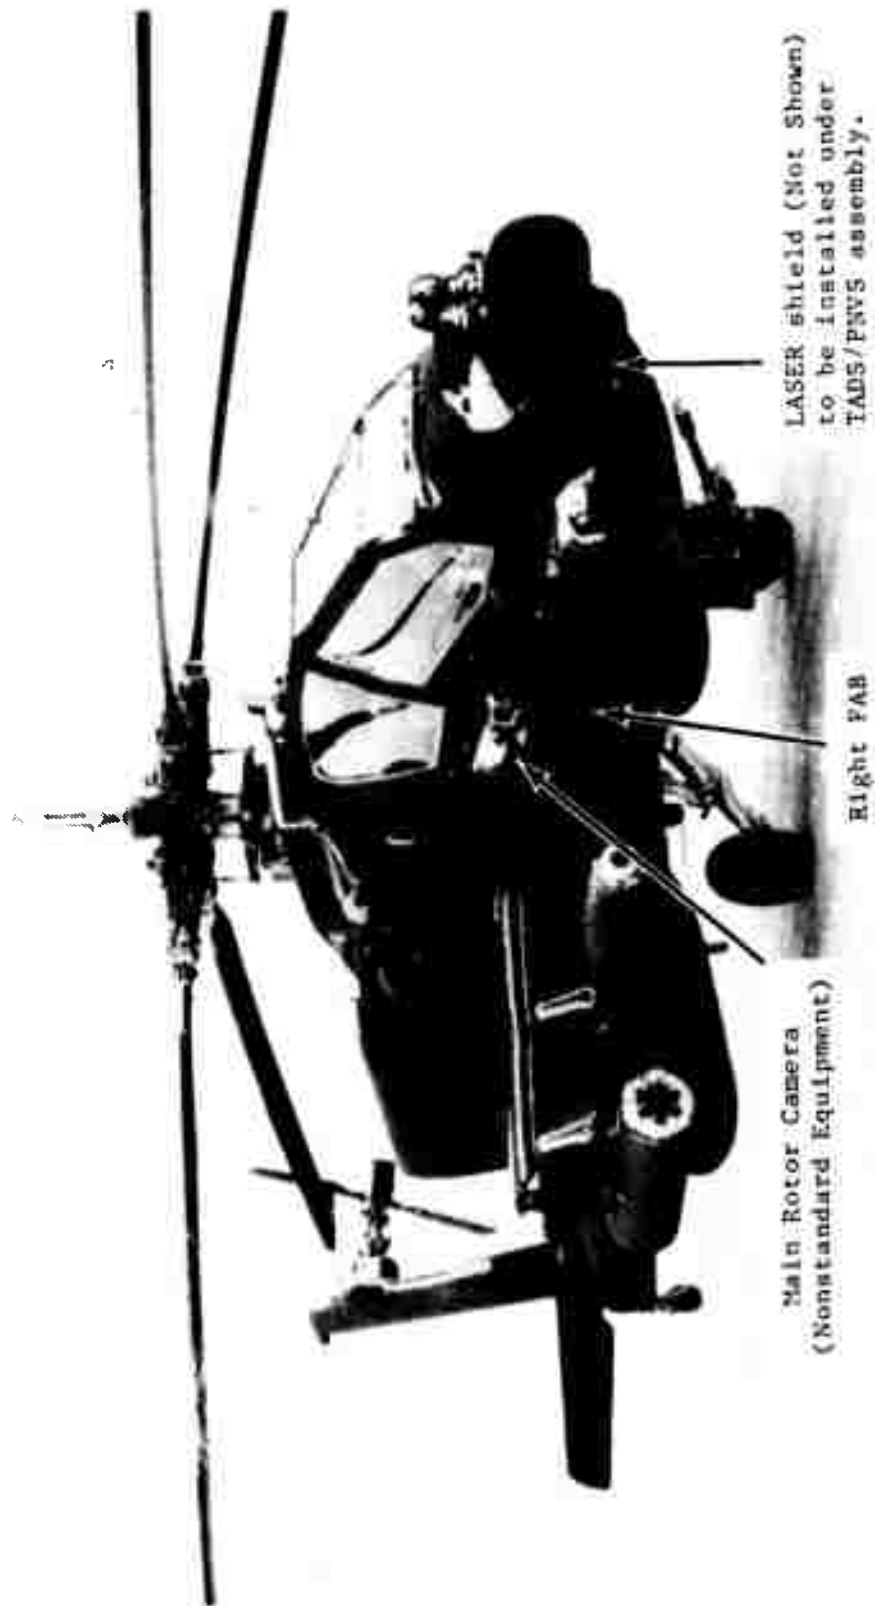
Photo 5. AH-64 - Right Front View

3. Four video cameras were located on the test aircraft to document ice accretion characteristics. One camera was mounted on the right forward avionics bay to photograph the main rotor advancing blade leading edge and lower surface (photo 5, encl 5). Another camera located on the top of the left wing tip photographed the tail rotor and horizontal stabilator (photo 7, encl 5). The third camera photographed the left engine inlet (photo 7, encl 5). A fourth camera was mounted on the transmission access panel for three flights to document ice accretion on the right engine aft nose gearbox cross shaft fairing (photo 15, encl 5).

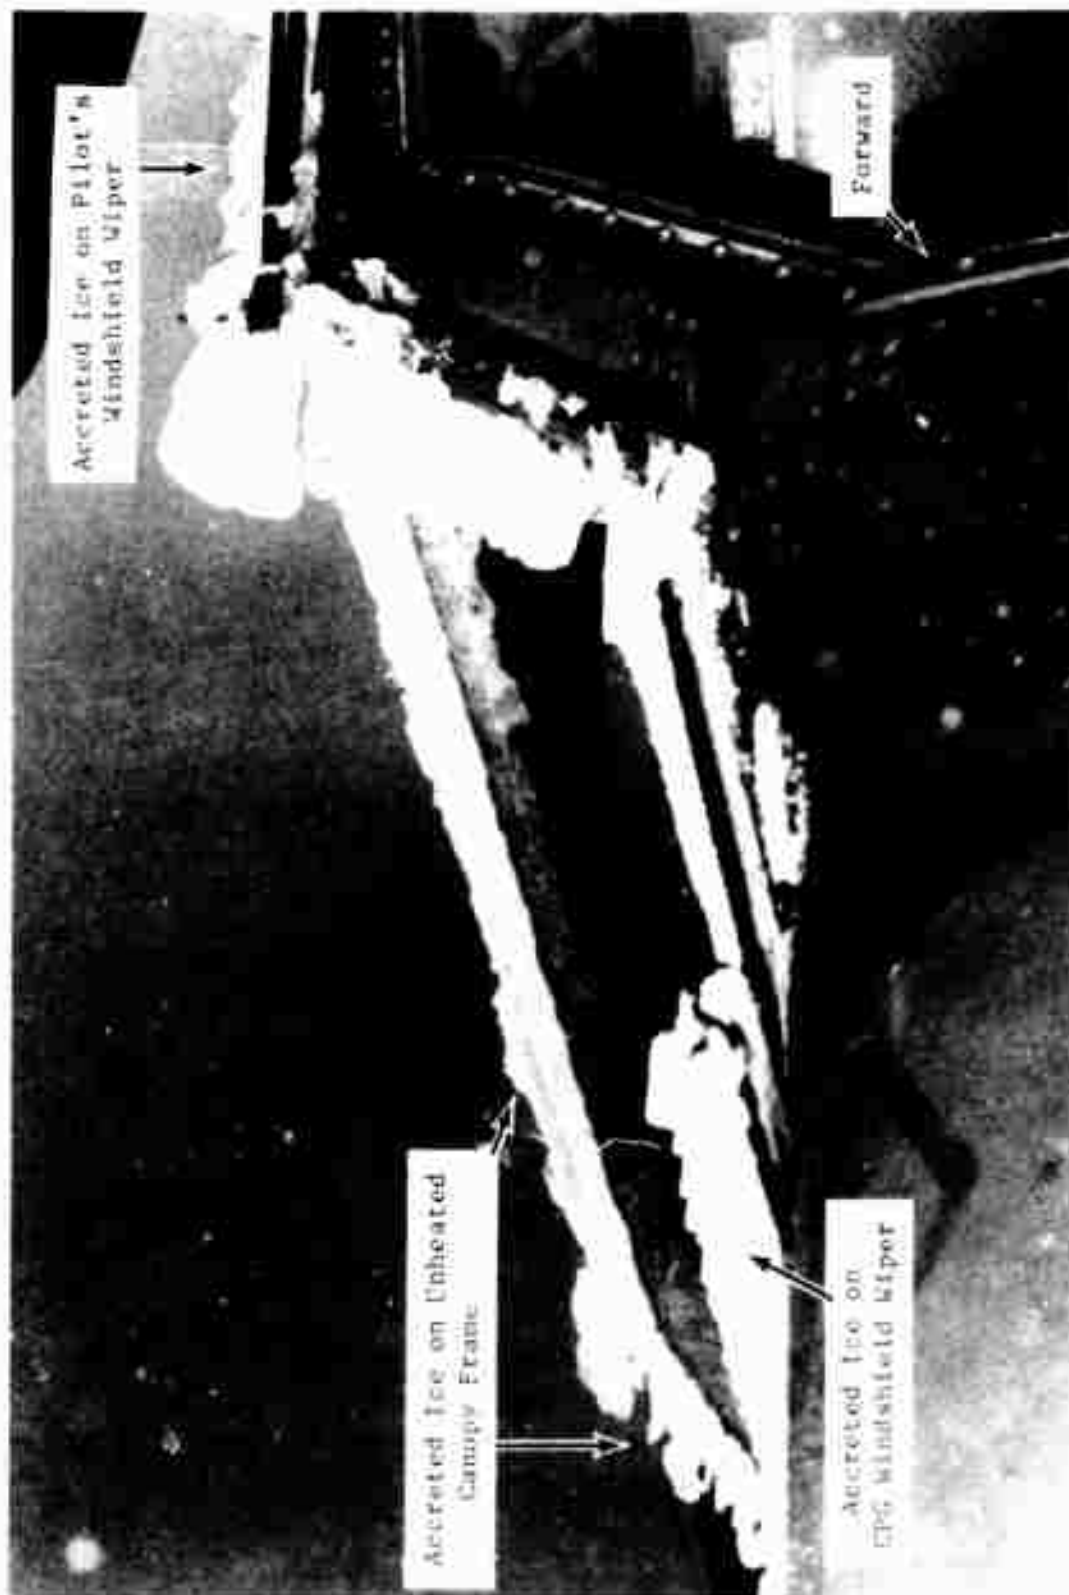
Photo 9. Ah-64 Forward Canopy

(6) Canopy Frames. The framework supporting the essentially flat plate canopy was not anti-iced. The forward canopy frames accreted large quantities of ice (photo 9, encl 5). The CPG windshield wiper was used for removal of water which pooled on the heated glass window. This water and the accreted ice (particularly around the CPG window) combined to form significant ice accumulations on the canopy frames and windshield wiper arms. These ice formations became large enough to break away during flight and could impinge on the nose gearbox or be ingested by an engine. Ice accretion and shedding from the canopy frames should be further evaluated in a more severe natural icing environment.

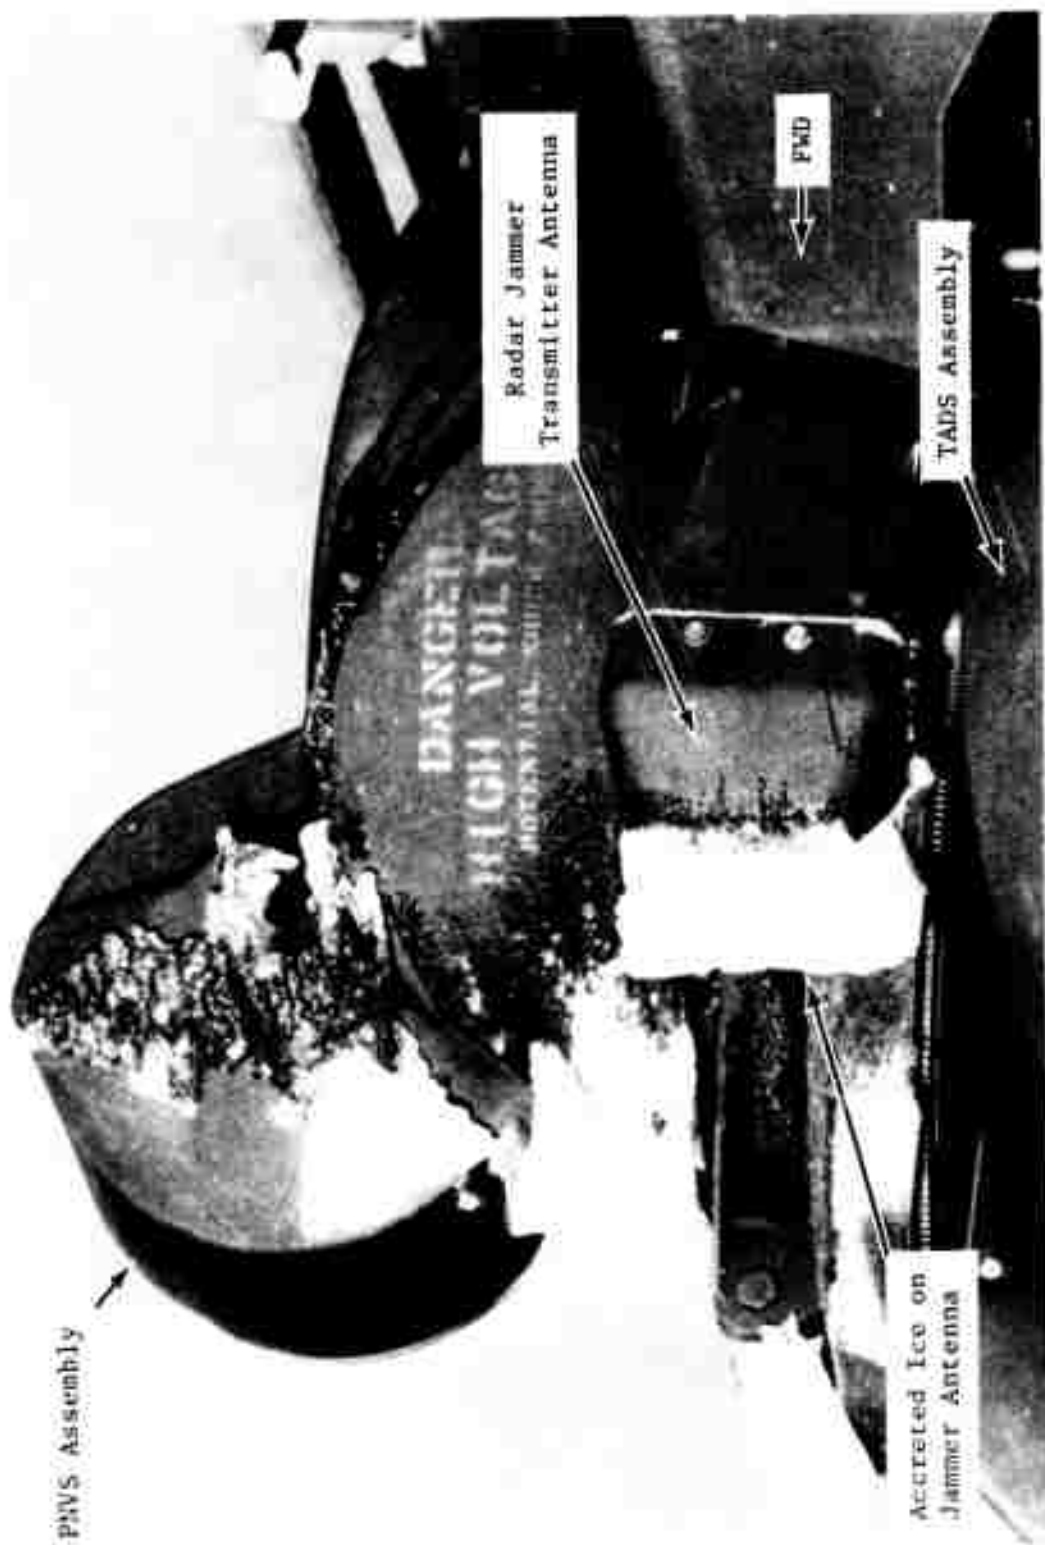
Photo 14. AH-64 TADS/PNVS - Left Front View

(16) Radar Jammer Antennas. A radar jammer transmitter antenna was mounted on the TADS/PNVS capsule (photo 14, encl 5) and a radar jammer receiver antenna was mounted on the upper fuselage (photo 1, encl 5). Operation of these antennas were not evaluated during the artificial icing tests (ref 1f). The 20 natural icing flights with these antennas installed included only two flights with LWC  $> 0.3 \text{ gm/m}^3$ . Large ice accretions on the unprotected radar jammer transmitter antenna could possibly restrict PNVS capsule motion. The potential for restriction of PNVS capsule range of movement by large ice accretions on the unprotected radar jammer transmitter antenna should be further evaluated in more severe natural icing conditions.
